**DEPARTMENT OF TRANSPORTATION**

Contract #: 04-0120F4Cty: SF/ALA Rte: 80 PM: 13.2/13.9File #: 1.28**WELDING INSPECTION REPORT****Resident Engineer:** Casey, William**Address:** 333 Burma Road**City:** Oakland, CA 94607**Report No:** WIR-026389**Date Inspected:** 21-Sep-2011**Project Name:** SAS Superstructure**OSM Arrival Time:** 700**Prime Contractor:** American Bridge/Fluor Enterprises, a JV**OSM Departure Time:** 1530**Contractor:** American Bridge/Fluor Enterprises, a JV**Location:** Jobsite**CWI Name:** As noted below**CWI Present:** Yes No**Inspected CWI report:** Yes No N/A**Rod Oven in Use:** Yes No N/A**Electrode to specification:** Yes No N/A**Weld Procedures Followed:** Yes No N/A**Qualified Welders:** Yes No N/A**Verified Joint Fit-up:** Yes No N/A**Approved Drawings:** Yes No N/A**Approved WPS:** Yes No N/A**Delayed / Cancelled:** Yes No N/A**Bridge No:** 34-0006**Component:** SAS OBG**Summary of Items Observed:**

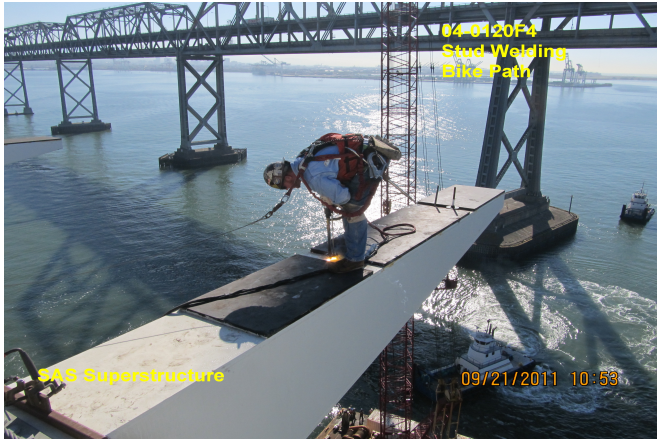
The QA Inspector continuously observed ABF operator Julian Paulk ID#7796 performing Stud Welding in the down hand position of 7/8 studs at the following locations; 11W PP105, 11W PP107, and 11W PP109. The QA Inspector observed the QC Inspector William Sherwood as being present in order to monitor the progress and ensure the welding parameters were in compliance with ABF-WPS-D15-5001 Stud. Upon placement of each stud, the weld was visually inspected for complete fusion (360 degrees) at the base. The work was completed on this date and the QA Inspector noted that the work appeared to be in general conformance with the contract documents.
